Monroe Masonic Temple Study Progress Review

Architectural – Structural Assessment

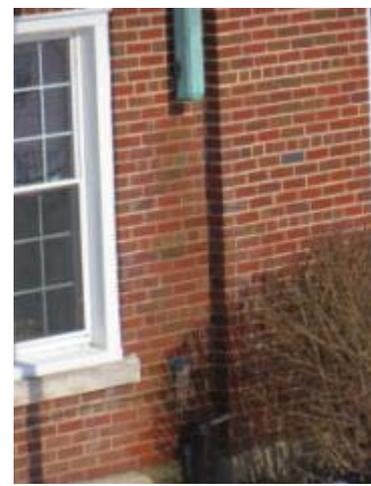
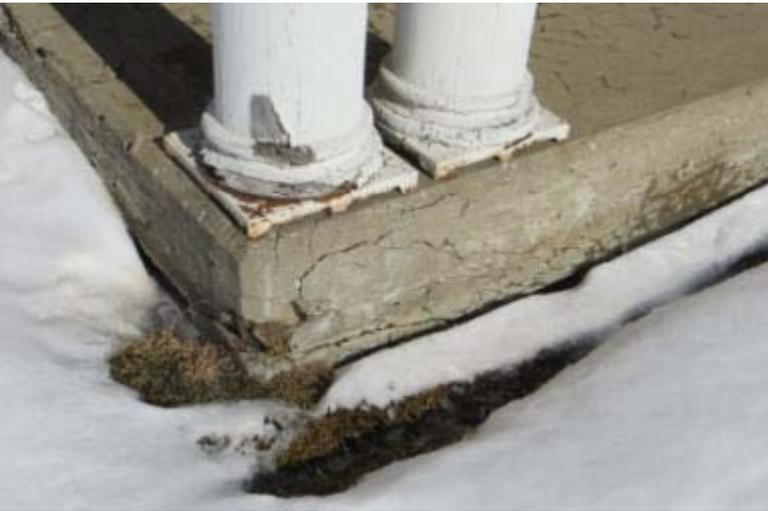
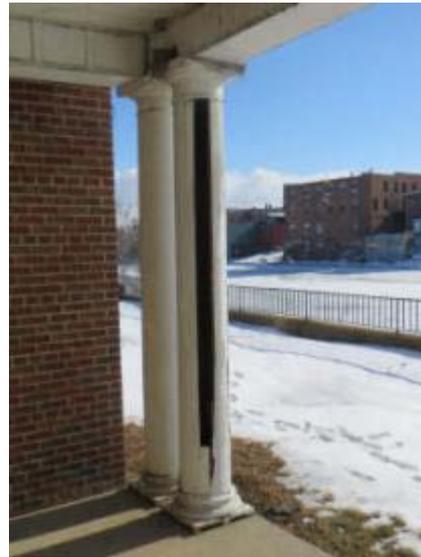
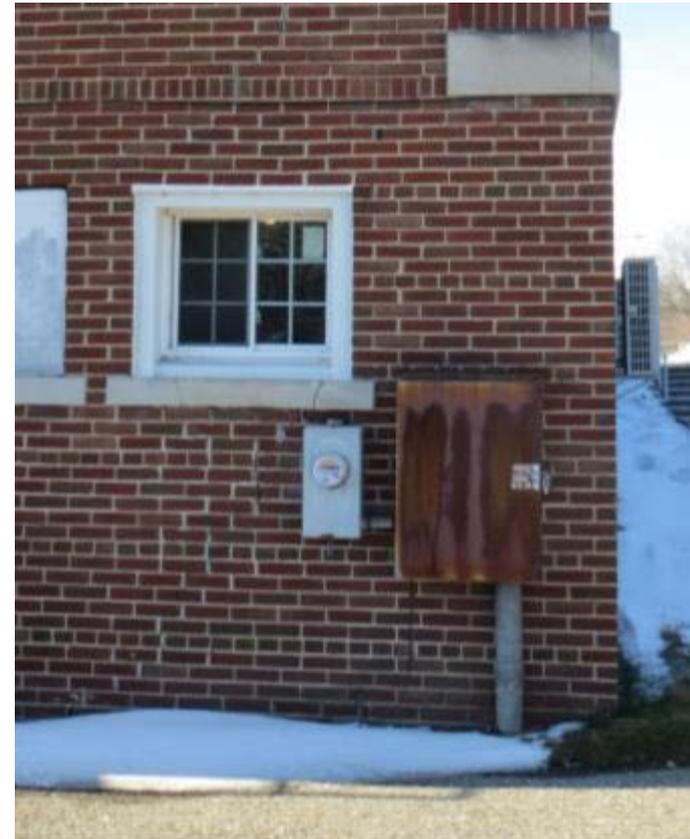
Exterior

Cracking on West (Monroe St) façade and at Northeast Corner.
Deteriorated porch slab and columns. Missing downspouts.
Balcony structure can support 75 psf live load.

- Repoint areas of cracking.
- Monitor for future movement.
- Replace porch slab.
- Rebuild porch columns, reinforce beam for balcony.

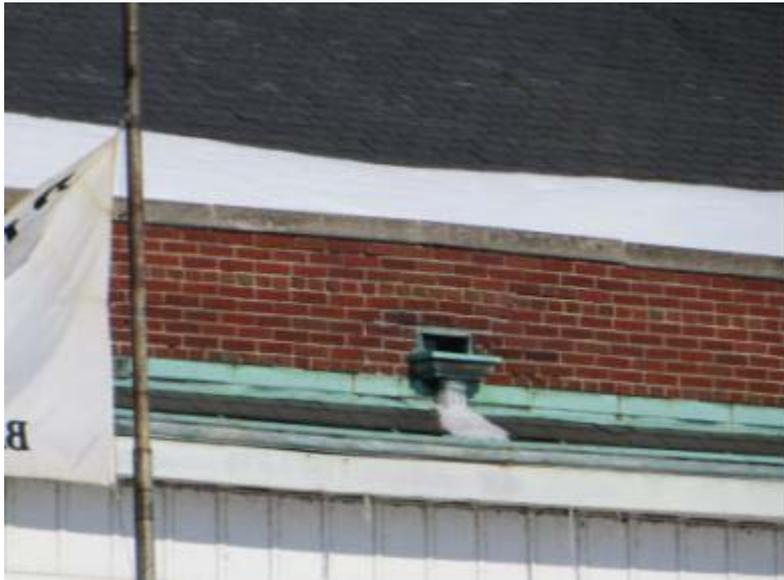
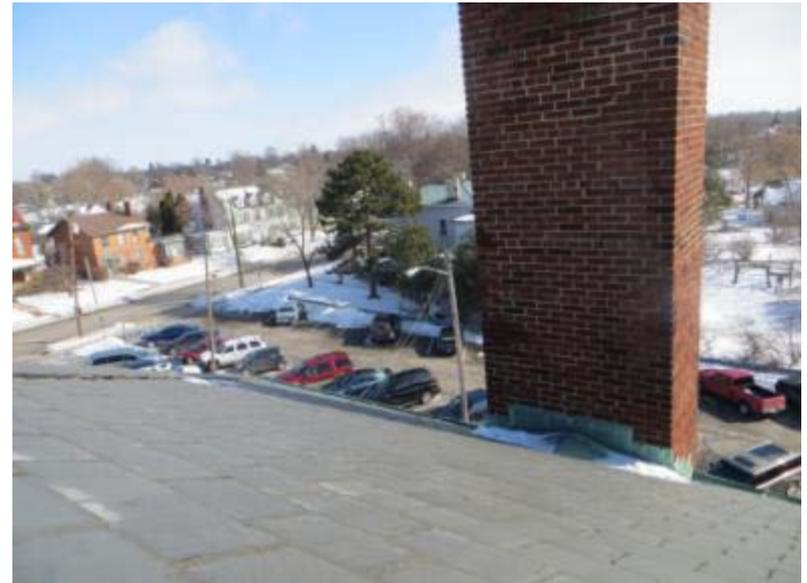
Roof

Slate is in good condition. Gutters have some replaced sections. Parapet walls need maintenance.

Repairs, replacement of roof and flashing on areas behind parapet walls.

Repointing parapet walls.

Survey with lift for extent of gutter replacement and condition behind parapet walls.
