RIVER RAISIN DAM REMEDIATION PROJECT JUNE 2012

River Raisin Dam Remediation Project

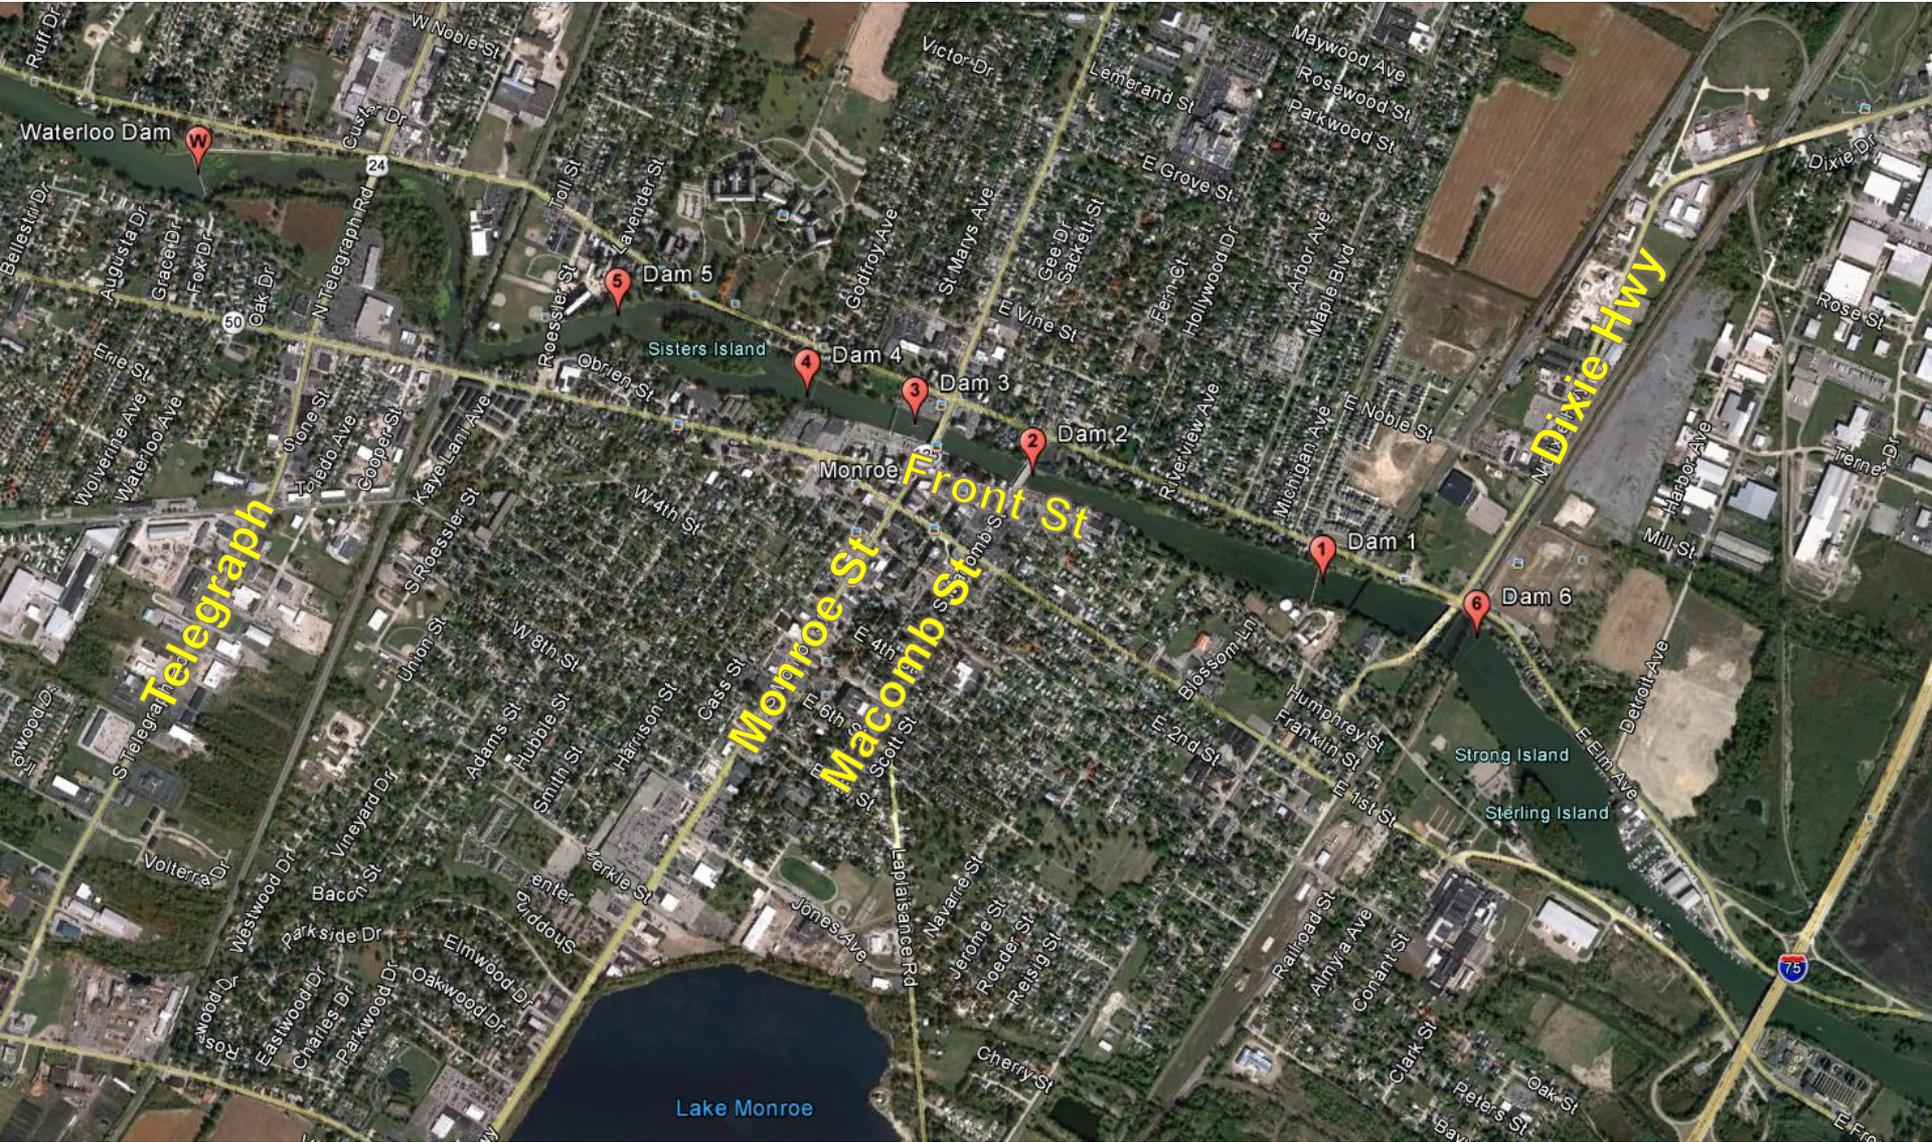
City Dams

- City's six low head dams (2.5-ft to 3-ft high) constructed by the Works Progress Administration – early to mid-1930's
- Used to carry sanitary sewer over the river's unique limestone bedrock and “beautify” downtown
- Currently, only 4 dams carry active sanitary sewer
- Waterloo Dam (owned by City) and Grape Dam (privately owned) are 5-ft to 6-ft high

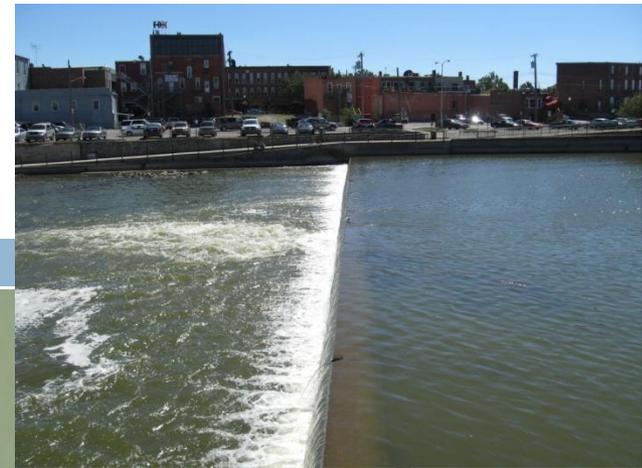
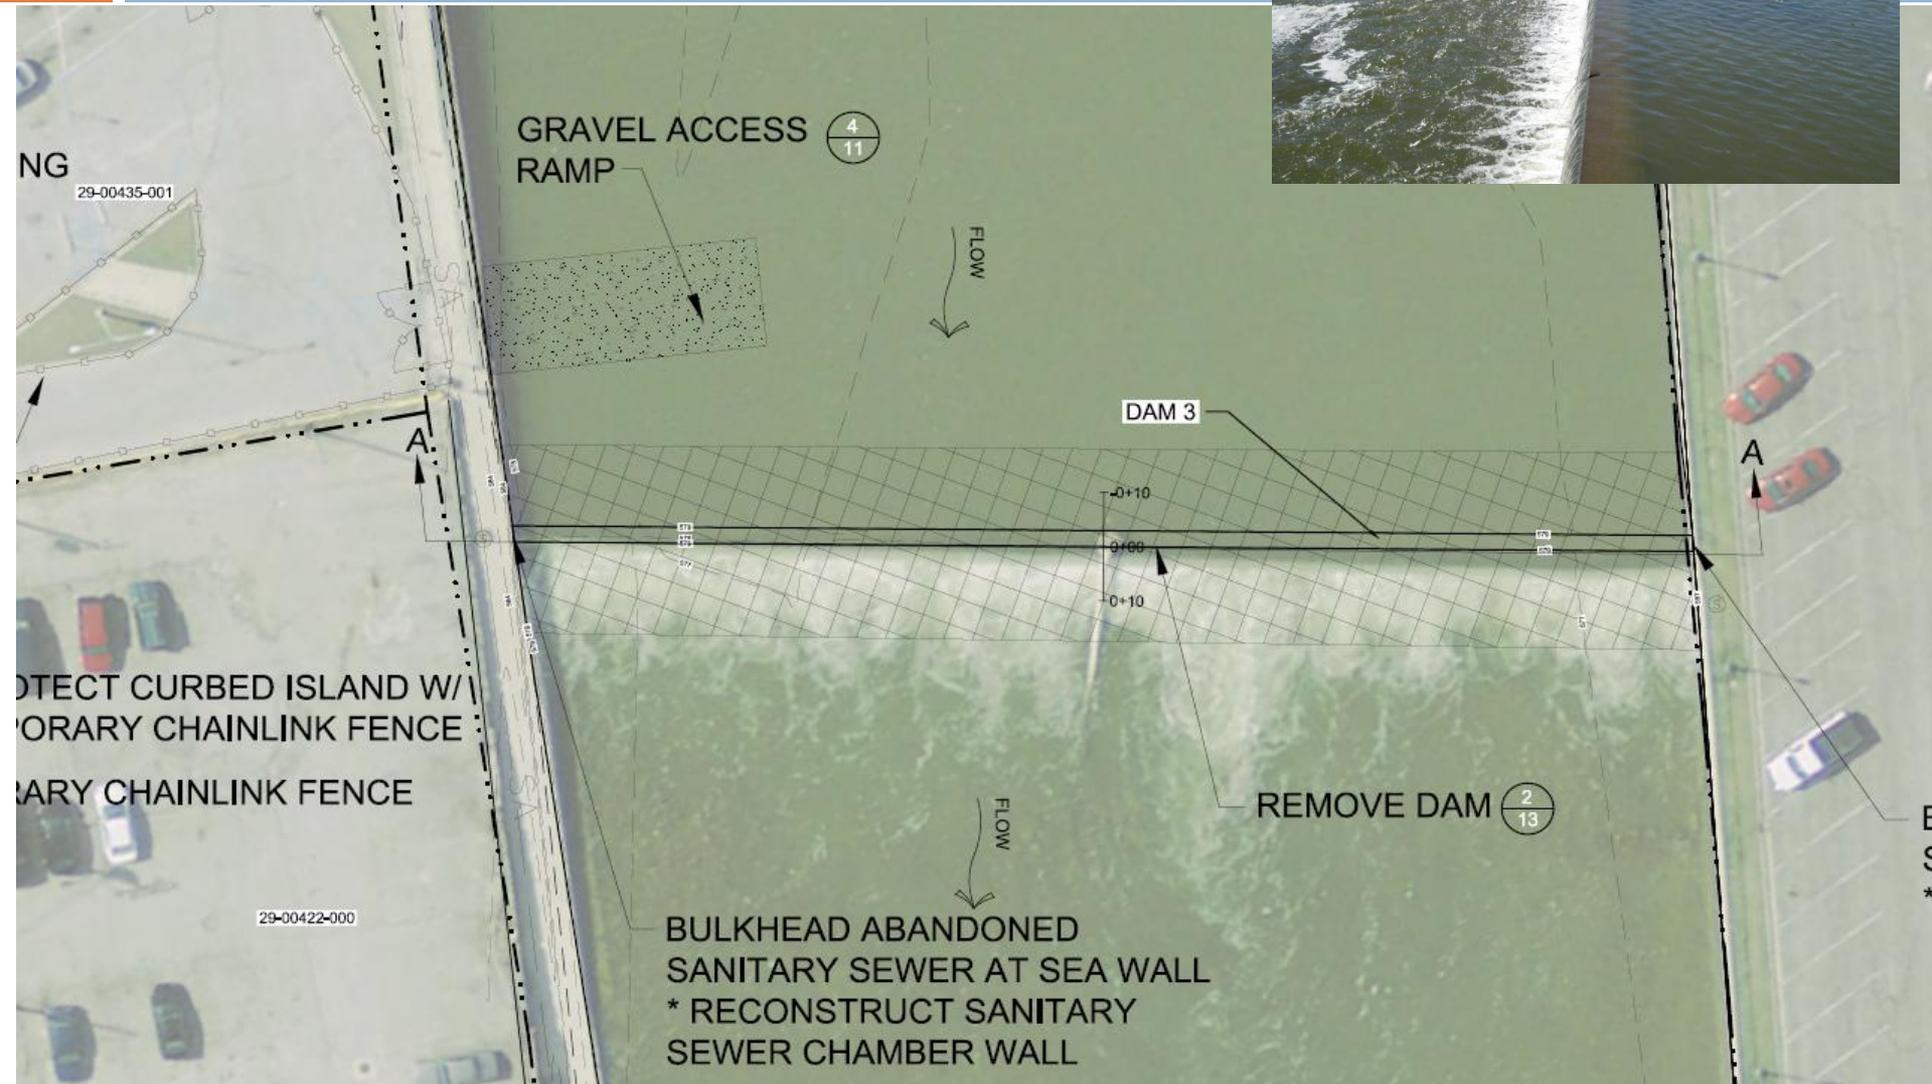
Phase 1 – Dam 3

GRAVEL ACCESS RAMP

PROTECT CURBED ISLAND W/
TEMPORARY CHAINLINK FENCE
TEMPORARY CHAINLINK FENCE

BULKHEAD ABANDONED
SANITARY SEWER AT SEA WALL
* RECONSTRUCT SANITARY
SEWER CHAMBER WALL

REMOVE DAM

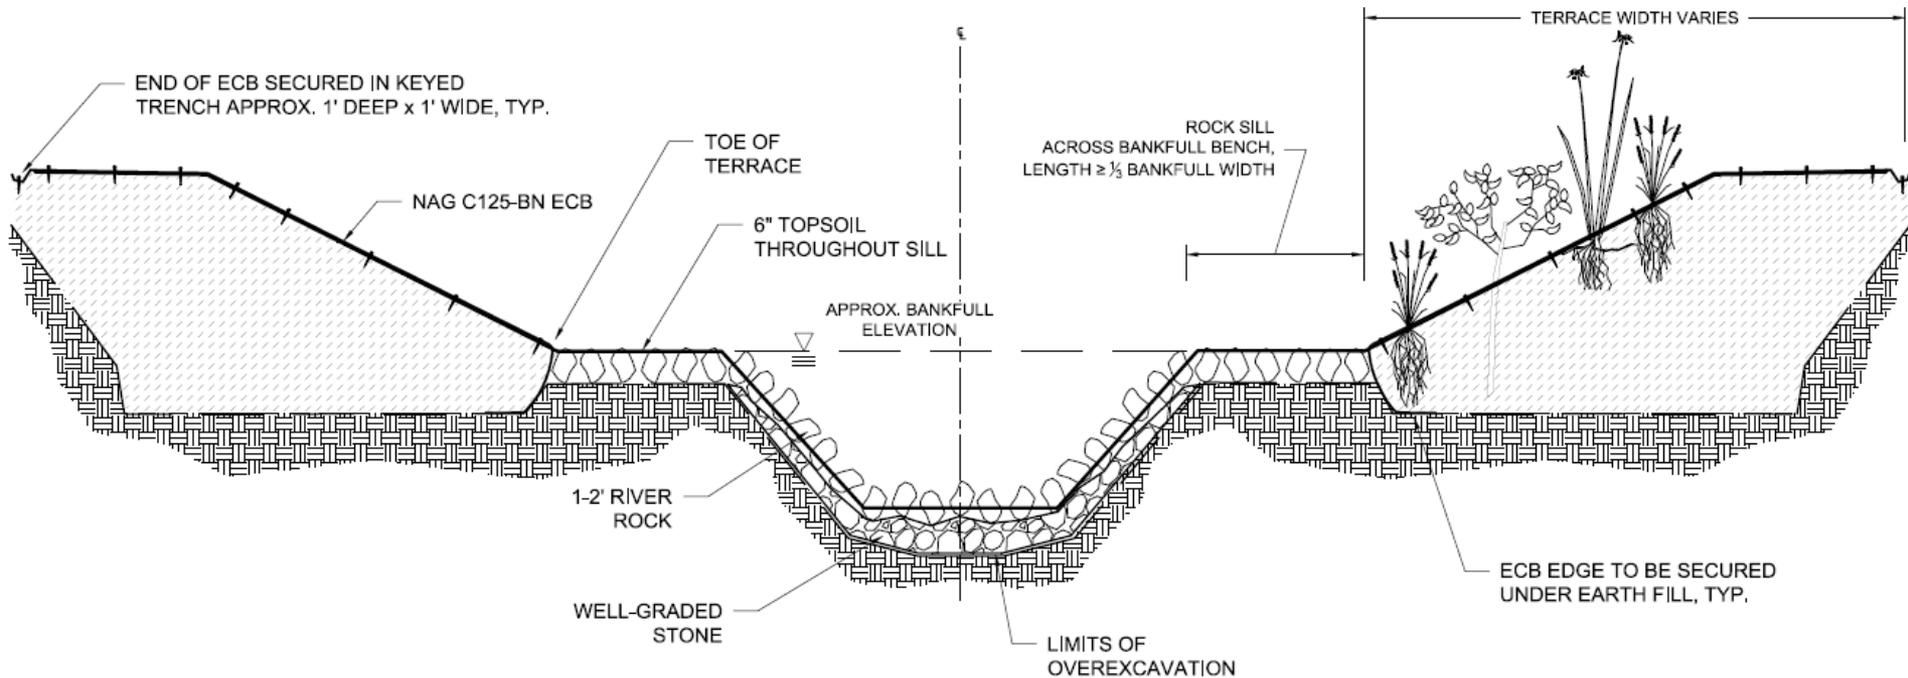
Conceptual Channel around Waterloo Dam

WATERLOO FISH CHANNEL - TYPICAL RIFFLE DETAIL
